Pelican Lake Watershed Restoration Plan

June 2017

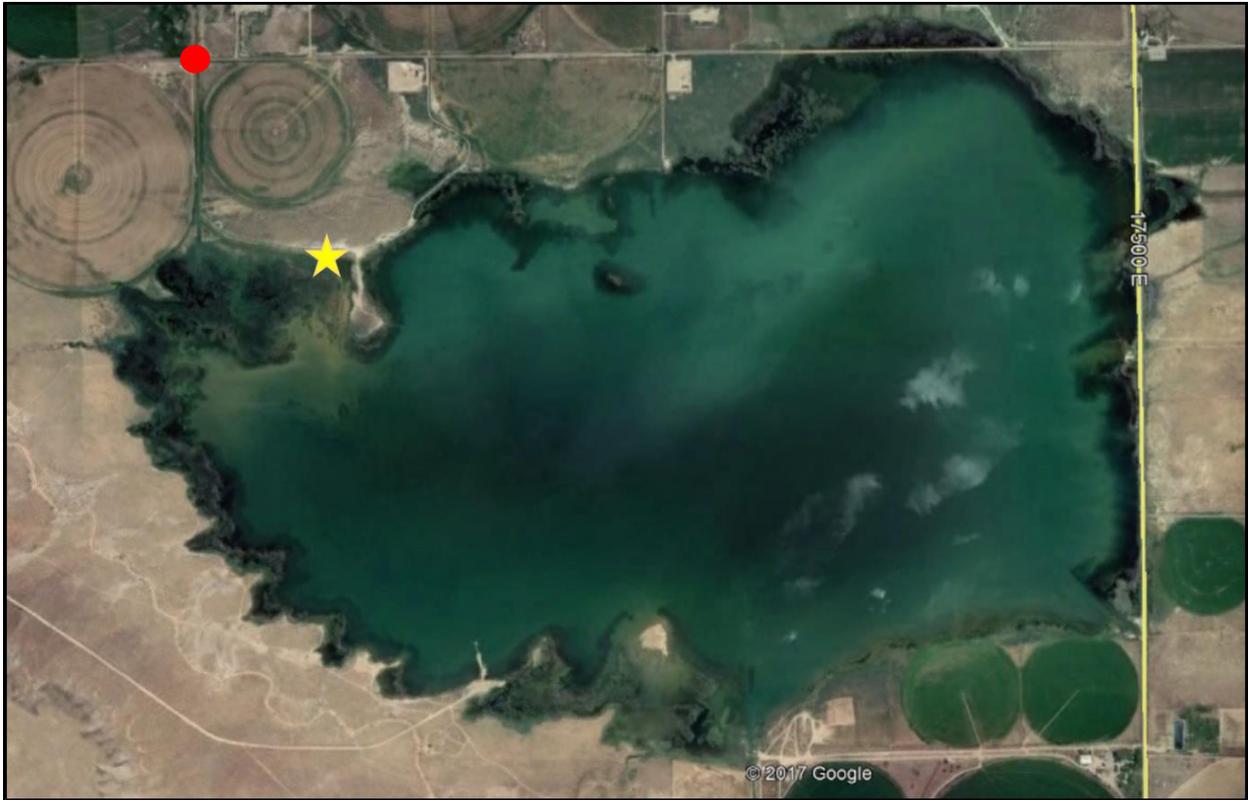
Figure 20. Location of the canal feeding Pelican Lake denoted by the yellow star. The red dot indicates the location where photos were taken (Figure 21a and Figure 21b).

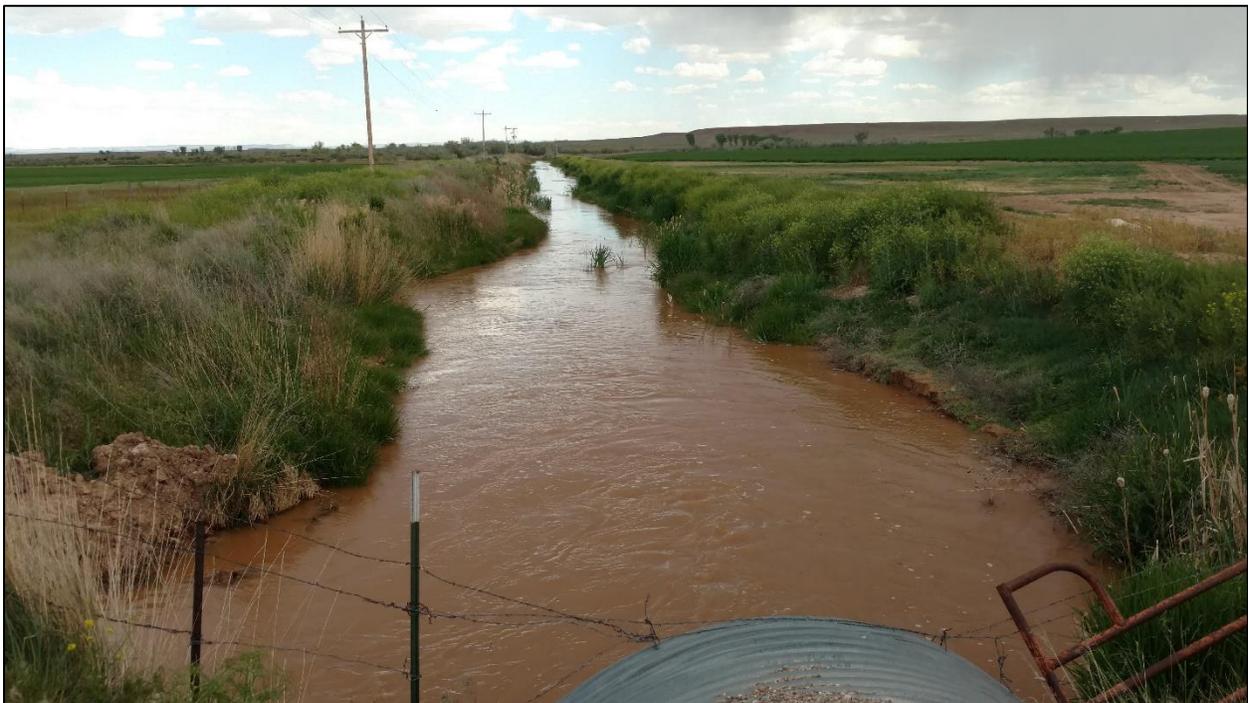
Figure 21a. The canal feeding the lake. Photo was taken on 05/15/17 approximately 0.6 miles north of the lake (facing south).

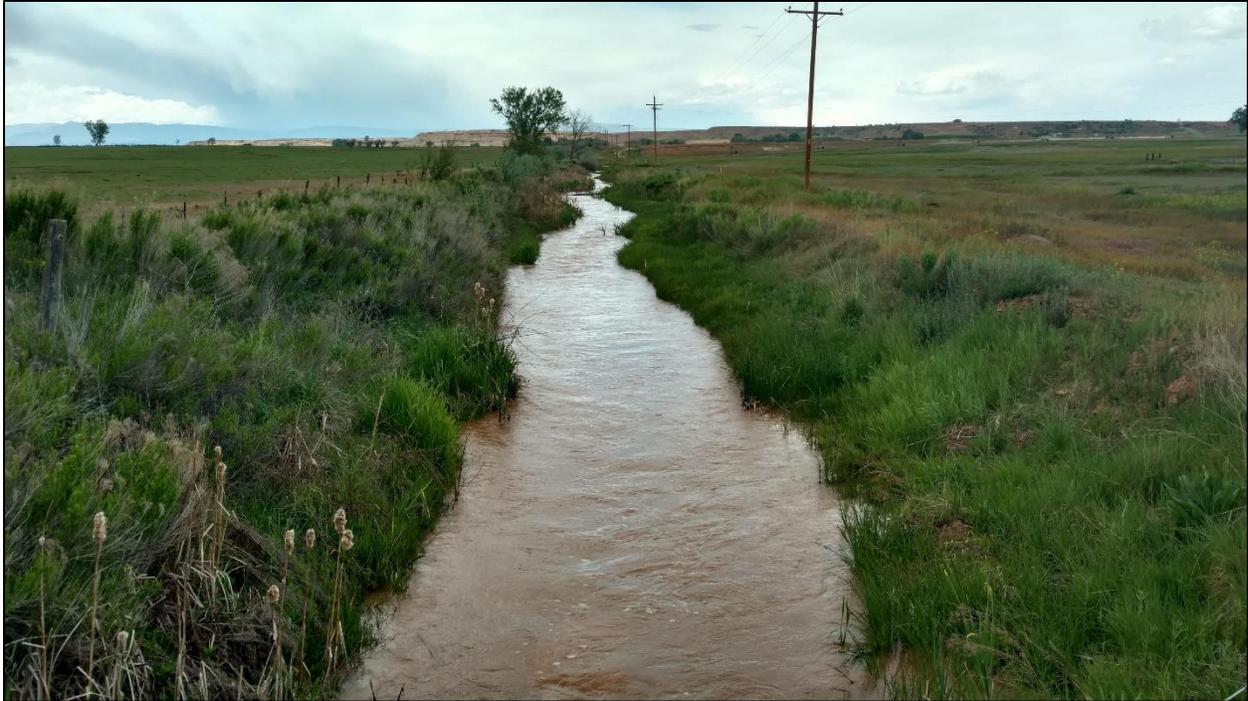
Figure 21b. The canal feeding the lake. Photo was taken on 05/15/17 approximately 0.6 miles north of the lake (facing north).
